Advantech AE Technical Share Document

Date	2018/06/12	SR#	1-3419358527
Category	<input checked="" type="checkbox"/> FAQ <input type="checkbox"/> SOP	Related OS	N/A
Abstract	What to do when following error message occurs after FW upgrade (Error Code 500)		
Keyword	WISE, firmware upgrade, error code 500.		
Related Product	WISE-4012, WISE-4012E, WISE-4050, WISE-4051, WISE-4060, WISE-4220-S231

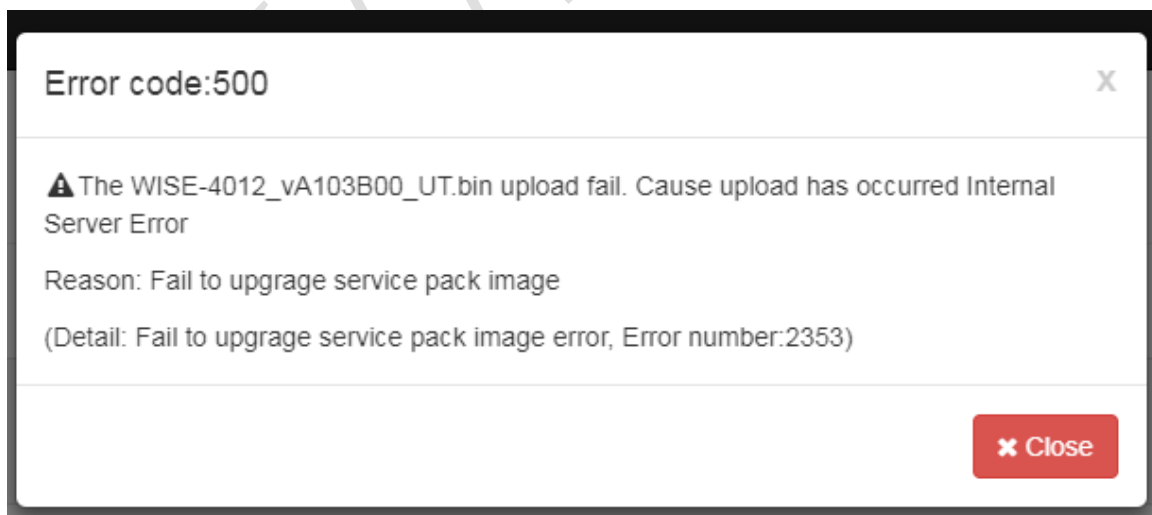
After upgrading firmware and it shows failure and error code 500 on utility. Why does a user open the web utility or ADAM utility to check the firmware version, and he/she can find out FW has been upgraded after manually power cycle. But if a user tried to upgrade again, the utility still shows up error code 500, as shown in figure 1.

Figure 1. The pop-up message during upgrading firmware.

Suggest that if you face any issue about RF behavior recently. Please request the customer to upgrade the FW. If the error code 500 appears, then you would know it lacks the service package.

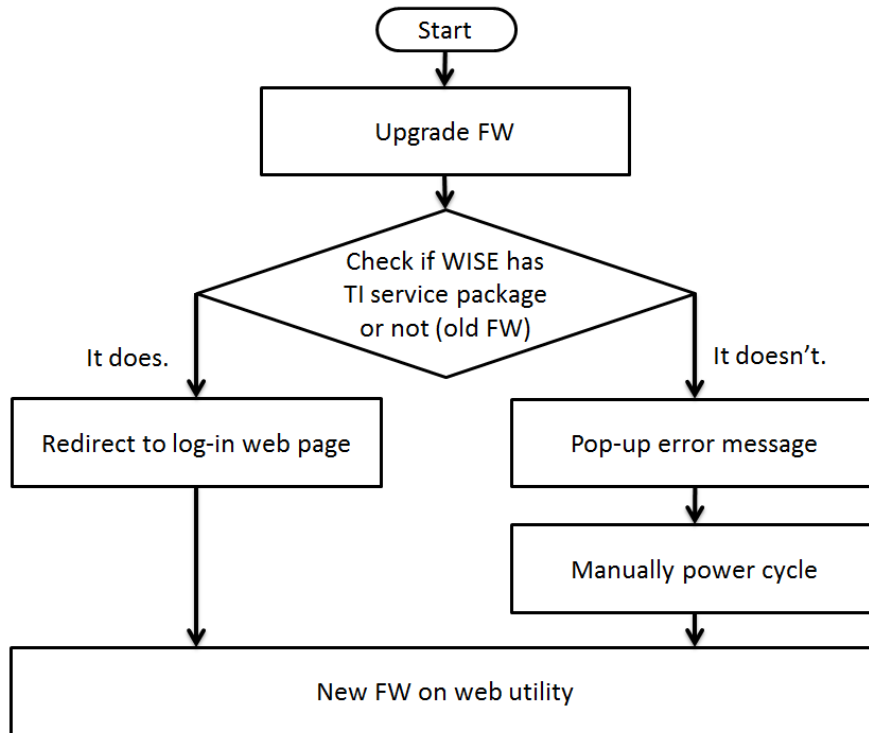
Figure 2. The behavior of firmware upgrade procedure.

As shown in figure 2, the firmware will be upgraded and then check if the WISE module has corresponding TI service package SDK or not.

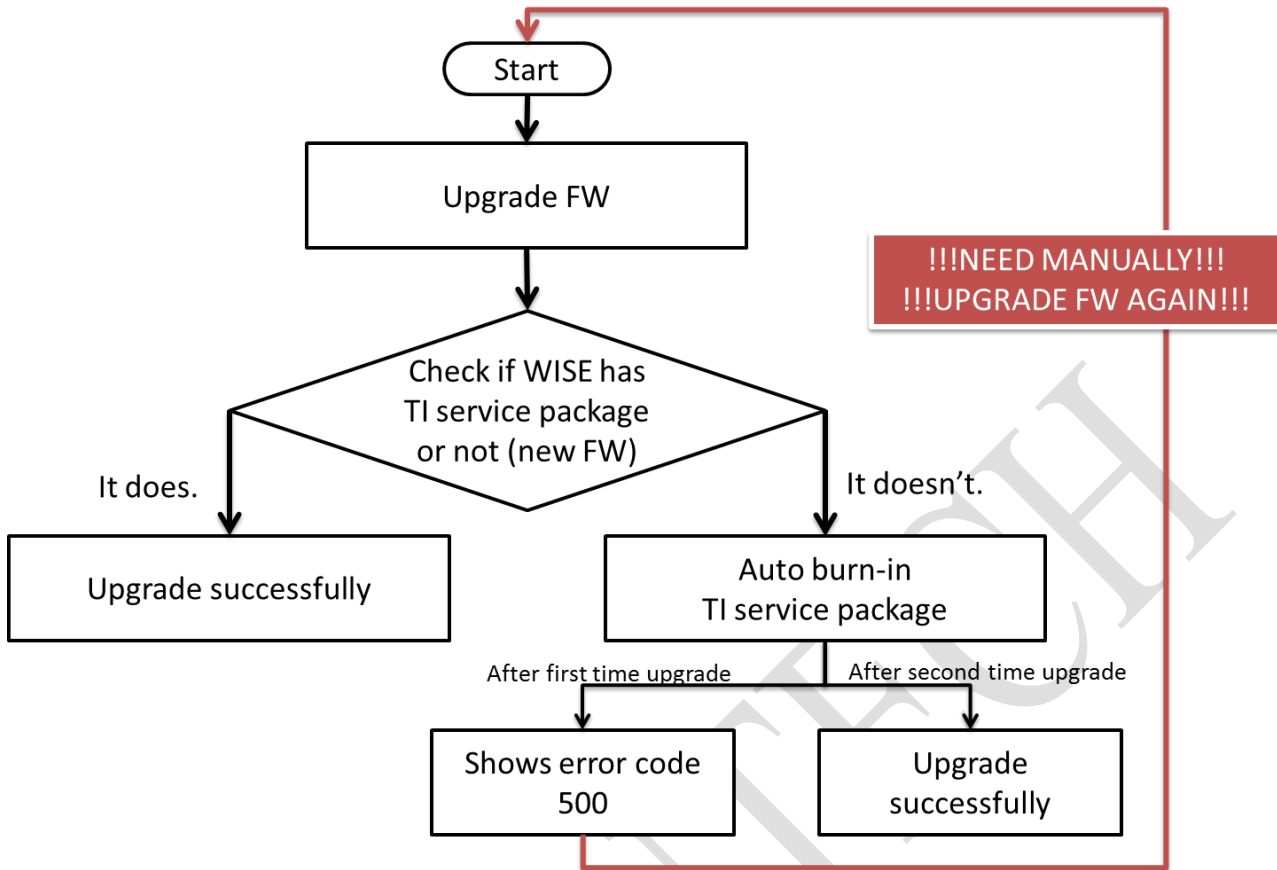
Figure 3. Firmware version with auto burn-in TI service package image.

FW team will modify the FW for all model type, which will help to burn-in the package if which does not exist. The procedure of new firmware is shown as in figure 3. For the new firmware of each module, please closely check the update on our official website.

Model	FW with auto burn-in TI service package	Firmware version
WISE-4012	○	A1.03 B04 and above
WISE-4012E	○	A1.12 B05 and above
WISE-4050	○	A1.12 B05 and above
WISE-4051	○	A1.11 B00 and above
WISE-4060	○	A1.12 B05 and above
WISE-4220-S231	○	A1.02 B04 and above
